9M-MRO Satellite Phone Connections

Summary

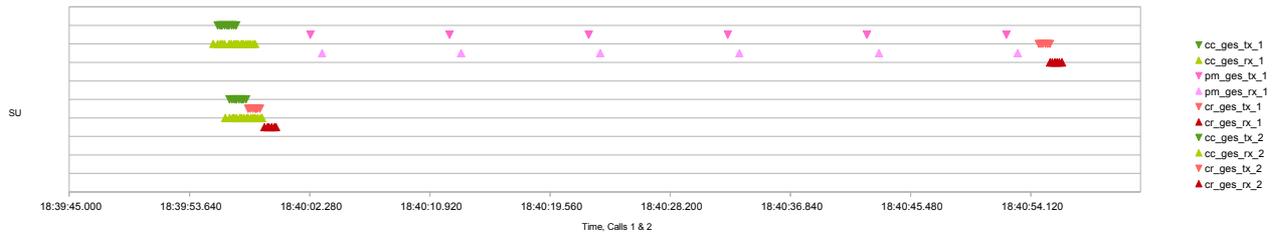
Illustration 1: Sub-channel signalling, Calls A and B

The outcomes of the call attempts are as follows:

- Calls A and C failed as a consequence of the “power management” test;
- Call B as a consequence of the “continuity test”.

In each sequence illustrated above, note where the Channel Release is initiated.

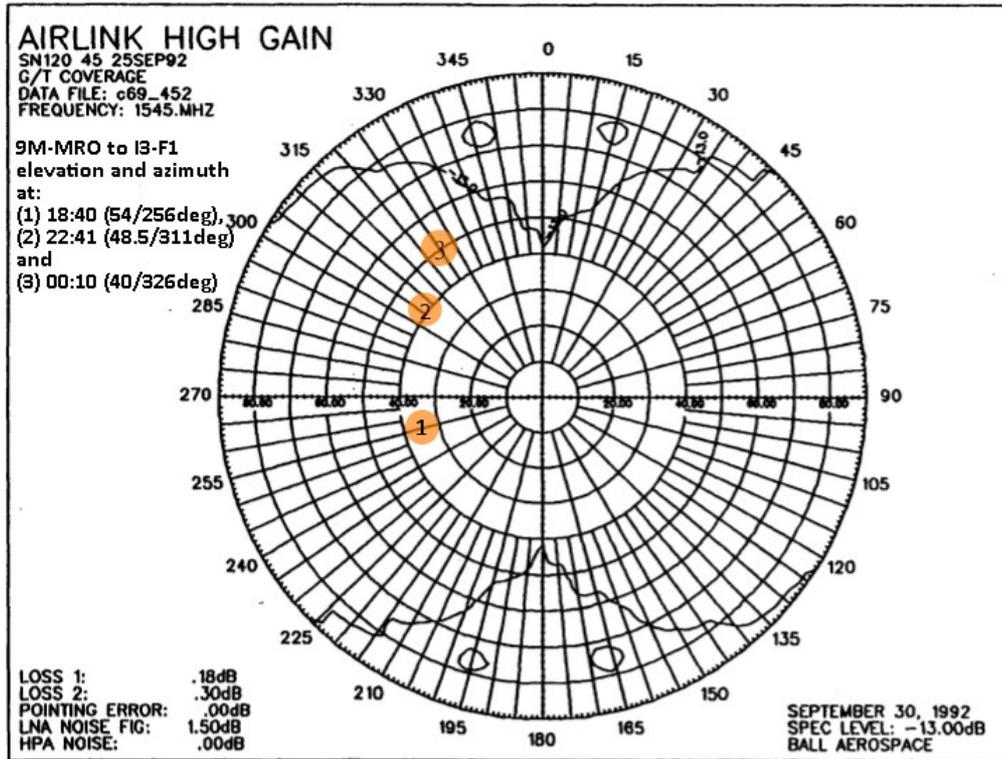
Illustration 3: Airlink Antenna Gain vs 9M-MRO position

The aircraft position at 18:39² (7.74°N, 94.35°E) places it for good elevation and azimuth range to I3-F1 and within the Ball Airlink 13dB gain boundary as depicted in Illustration 3. Similarly, the aircraft positions at 22:41 and 00:10 indicate that the estimated position at 23:13 affords a good signal.
